Therme Canada

**THERME CANADA | ONTARIO PLACE
SHORELINE SUMMARY REPORT
2023.09.13 Issued for OPA/ZBA Resubmission**

SSR-OPL-ED-P1

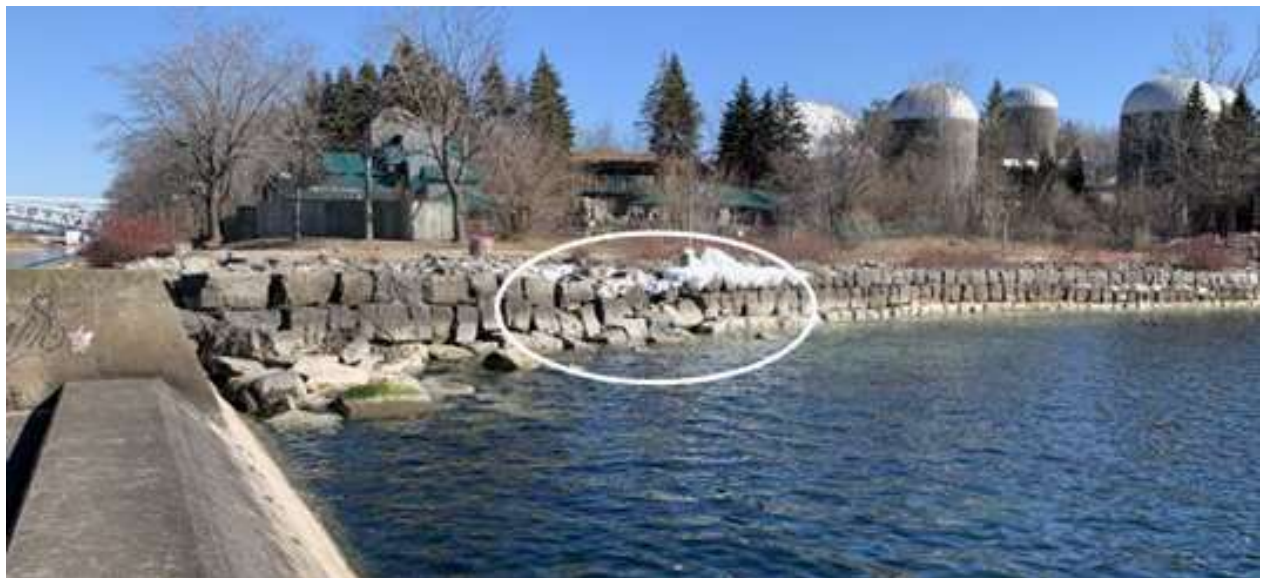
Figure 2.2: Collapsed portion of stacked armour stone seawall at west shore

The west shore is protected with a stacked armour stone seawall and random armour stone. Previous condition assessments did not identify specific defects with the stacked wall. However recent site visits by Baird and a further assessment by Shoreplan (2022)² have revealed that a section of the stacked wall has collapsed (see Figure 2.2). At design high water levels, the shoreline is overtopped by waves, and the backshore is flooded. The nearly vertical shorewall does not offer public access to the water's edge. The width of the existing walkway behind the shorewall is narrow, crowding pedestrians, strollers, and cyclists. There are no intentional aquatic habitat features incorporated into the shoreline.

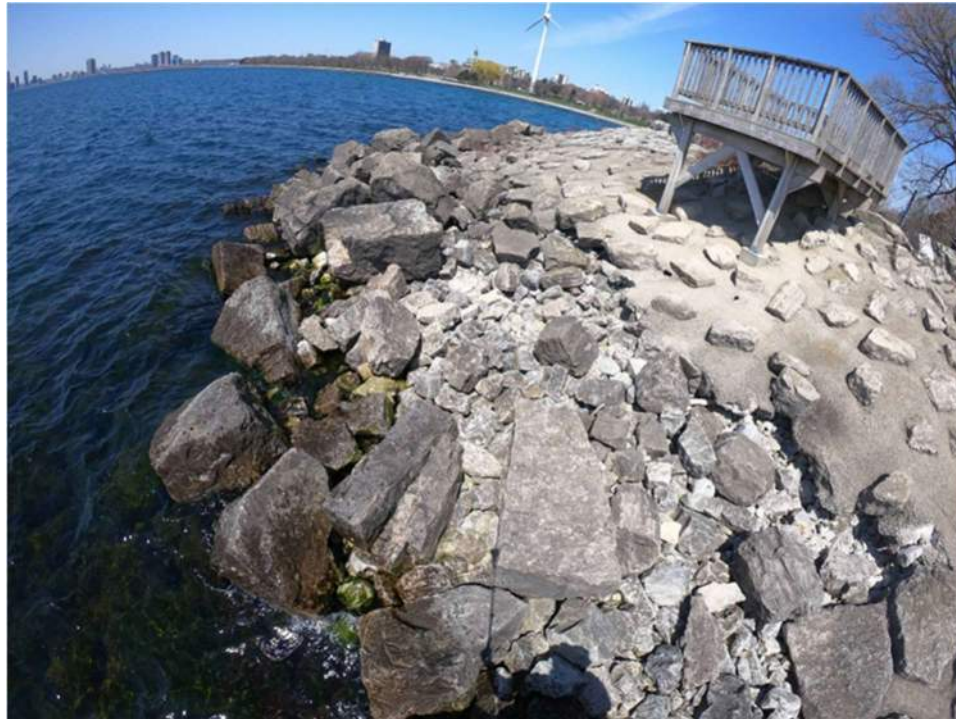
Figure 2.3: Deteriorated grouted armour revetment protection at west headland (Baird 2022-04-29)

The west headland is protected with a grouted stone revetment with additional armour stone on the lower part of the slope. Significant damage to the armour layer at the west headland was noted during a site visit on April 29, 2022, including loss of armour cover, exposure of underlying smaller stone material, and cracking of the grouted slope (see Figure 2.3). Shoreplan (2022) reported that there was significant toe damage near the tip of the western most portion of the revetment and that the grouted revetment has

collapsed in some areas exposing the underside of the revetment and the rip rap bedding. Deterioration of the armoured slopes at older lakefill sites is not an uncommon occurrence in Toronto.

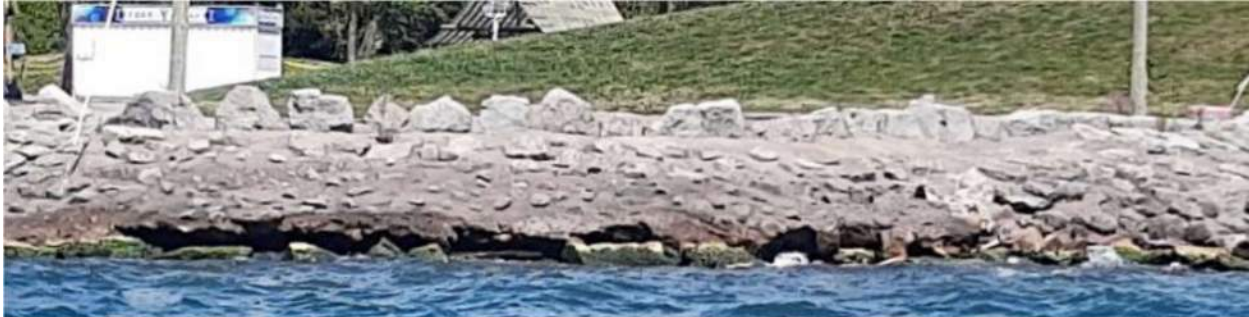
Figure 2.4: Deterioration of grouted stone revetment at east headland (from Jacobs, 2020)

The east headland is protected with a grouted stone revetment with additional armour stone on the lower part of the slope. Baird noted significant damage to the grouted armour layer at the east headland during a site visit on April 29, 2022. Jacobs (2020) reported that several cracks were observed in the grouted stone revetment, and some undercutting and loss of material was observed near the waterline (see Figure 2.4). Jacobs also identified that there is the possibility of additional undercutting below the waterline, which could eventually cause the revetment to collapse; however, they did not assess the damage below the waterline. Jacobs (2020) assessed the overall condition of the east headland revetment as “poor to serious.” Shoreplan (2012) also reported that the grout between the armour stones at the east headland was broken up and that there were large voids in the structure. Shoreplan concluded that the east headland was in poor condition and in need of repair. Shoreplan (2022) notes:

The crest elevation of the east headland is low relative to the design high water level and is subject to significant wave overtopping and flooding.

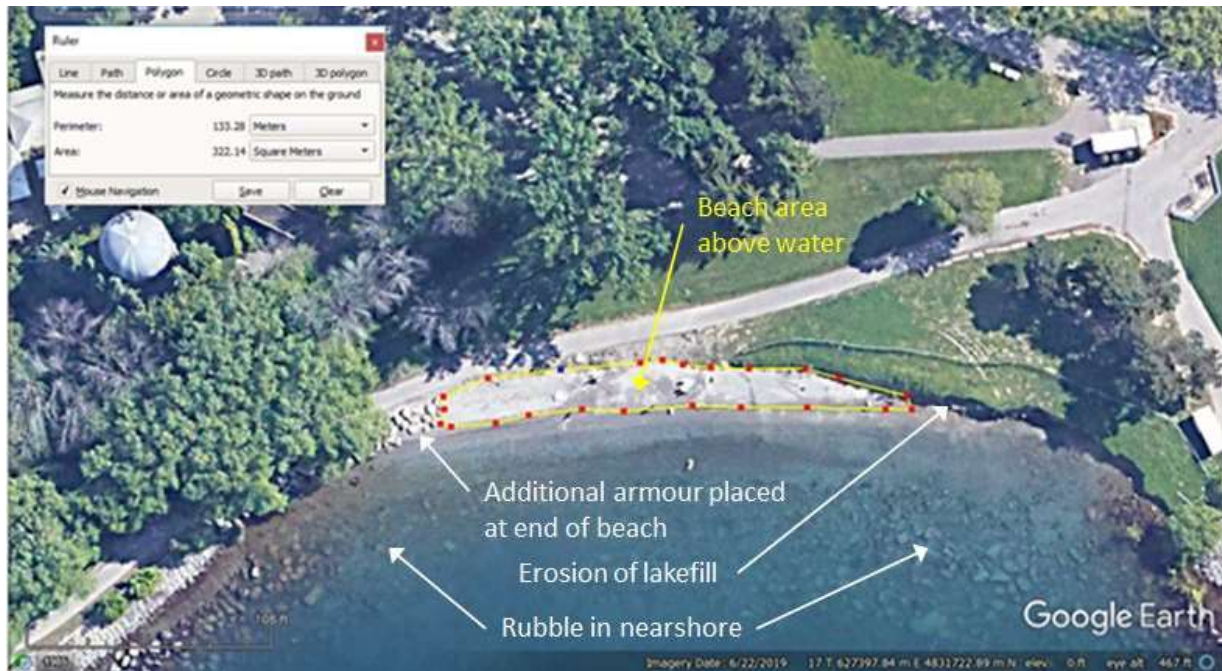
Figure 2.5: Narrow south shore (beach area above water approximately 320 m²); additional armour placed at west end; erosion of lakefill at east side; and rubble in nearshore (ref. Google Earth 2019/6/22)

The south shore, between the west and east headlands, consists of a relatively small, narrow perched beach (see Figure 2.5 and Figure 2.6). Above the waterline, remnants of the imported stone veneer that had been placed on the underlying rubble fill and worn-down pieces of the original construction rubble (e.g., concrete, brick, and asphalt) and material from the eroding lakefill are visible. Larger lakefill rubble material is exposed at the back of the beach by the walkway (see Figure 2.5 and Figure 2.6). Exposed lakefill rubble material is also evident in the nearshore area below the water (see Figure 2.5). Since the original construction of Ontario Place, the length south beach has decreased from about 120 m in 1972 to about 85 m at present due to the placement of additional armouring material at the ends of the beach to protect the backshore lakefill from erosion (e.g., see Figure 2.7 and Figure 2.8).

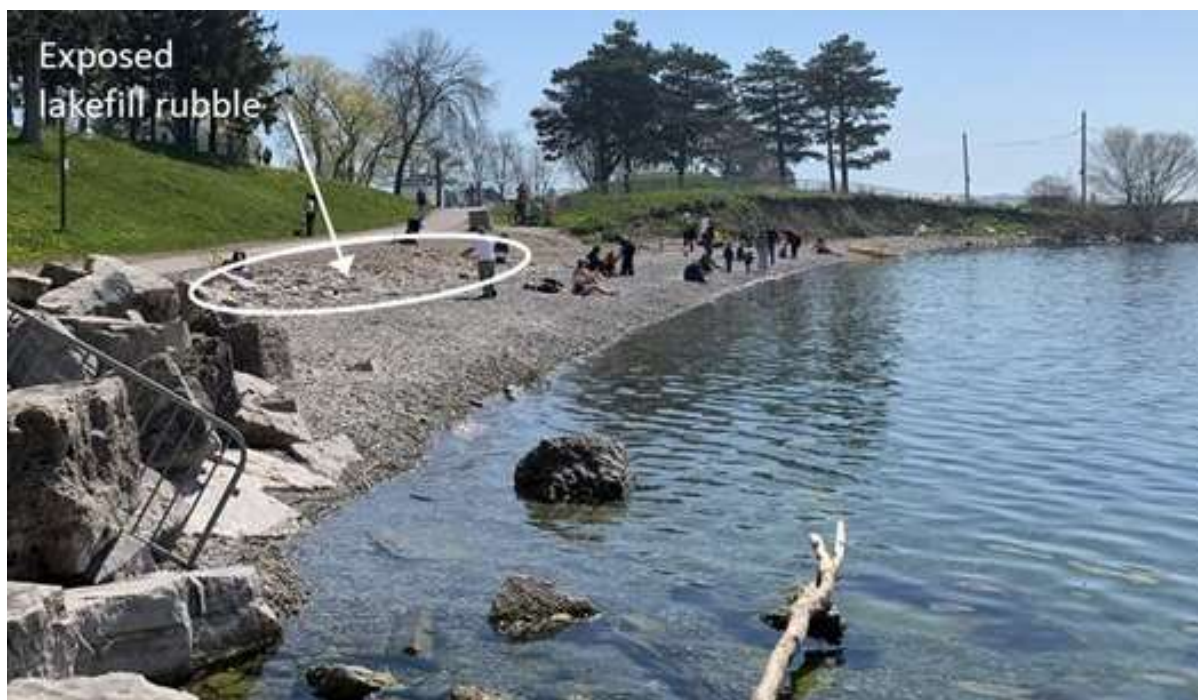
Figure 2.6: South shore with exposed lakefill rubble at the back of the beach (Baird 2023-05-06)

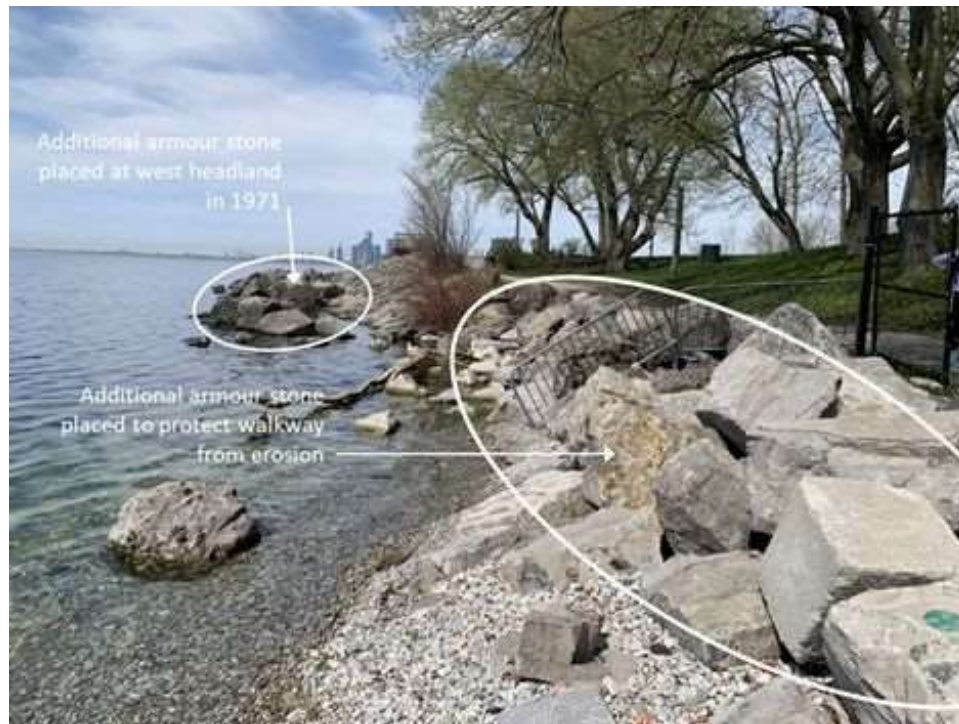
Figure 2.7: Additional armour stone placed at the west headland and at the west end of the beach to provide erosion protection to perimeter of lakefill (Baird 2023-5-06)

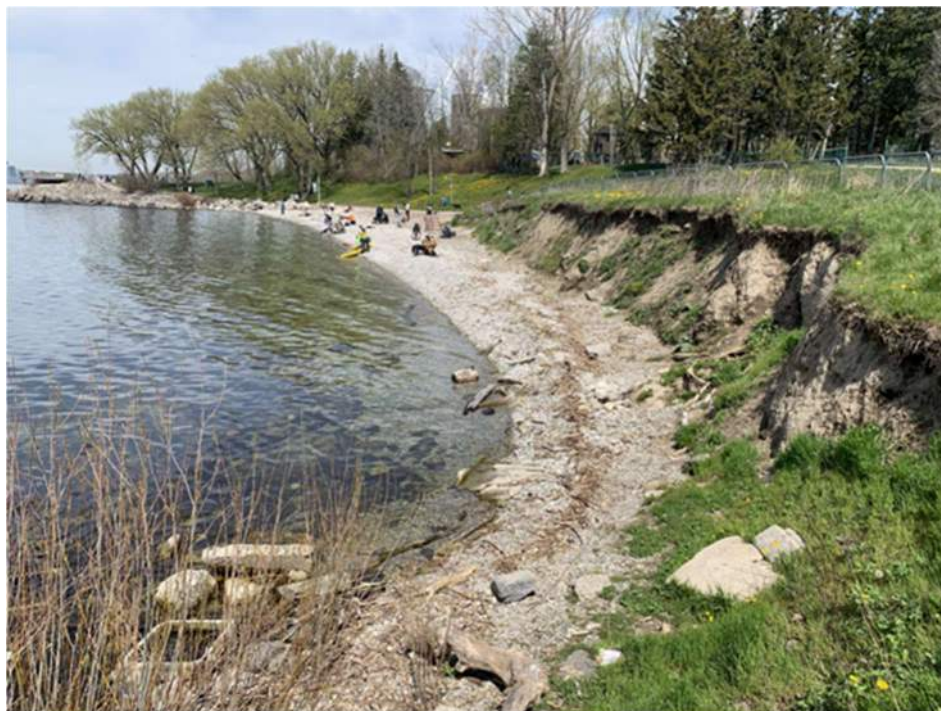
Figure 2.8: Narrow south shore and significant erosion of lakefill perimeter (Baird 2023-05-06)

Due to the narrow width and relatively low elevation of the beach, it is inundated at high water levels allowing waves to directly attack the backshore fill (see Figure 2.8). Ongoing erosion of the lakefill perimeter is evident at the shore. The width of the existing walkway along the south shore is narrow and subject to flooding and wave overtopping. The overall condition of the beach area was assessed by Jacobs (2020)⁴ as “fair to poor”; Shoreplan (2012)⁵ reported similar findings. Higher design water levels due to the Lake Ontario regulation plan and climate change impacts increase the risk of future flooding and erosion damage at the south shoreline.

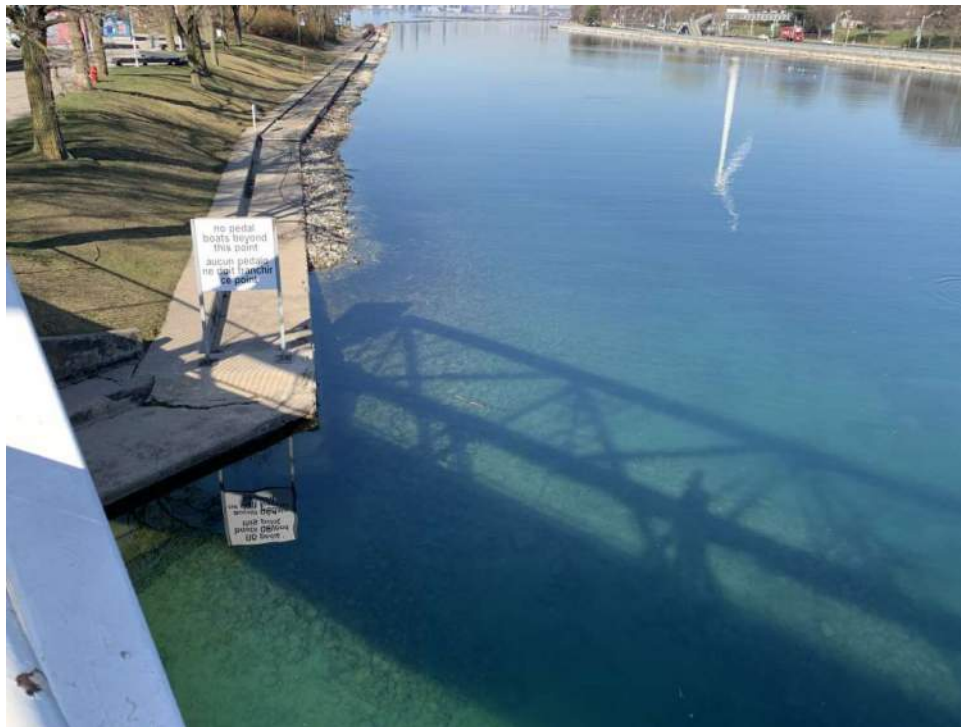
Figure 2.9: View looking west of the north wall of West Island (left-hand side of photo) with rip rap revetment protection.

The revetment appears to be in good condition, but the walkway is in poor condition. The crest elevation of the north wall is lower than the 100-year flood level, and the walkway and backshore area are subject to flooding. Jacobs (2020) assessed the overall condition of the flood defence as “fair.” The width of the walkway is narrow, crowding pedestrians and cyclists; it does not provide adequate space for emergency vehicle access.

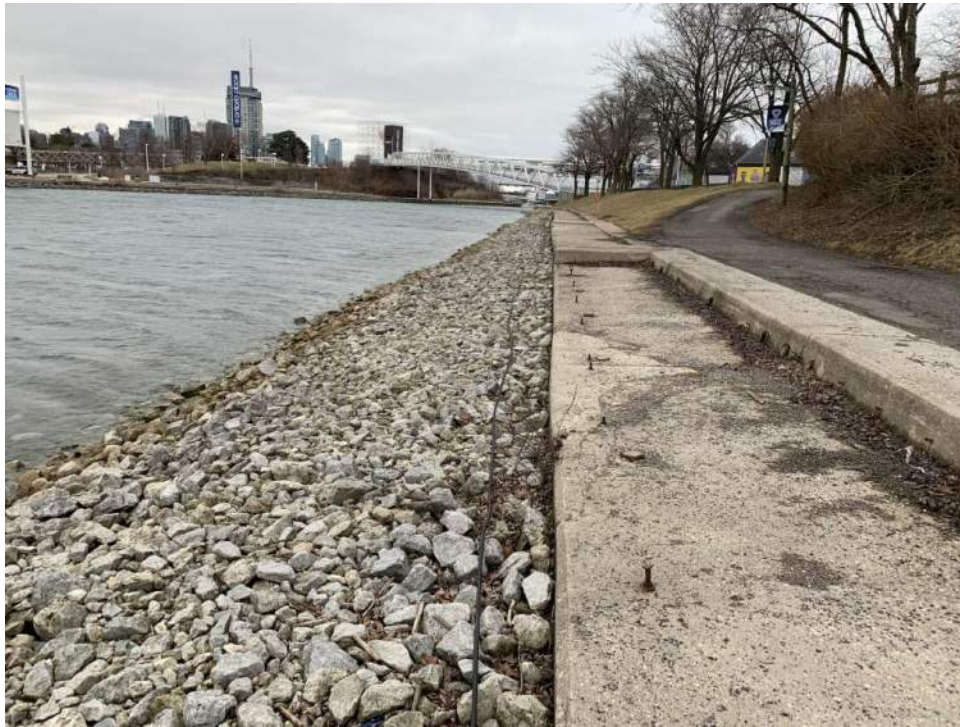
Figure 2.10: Rip rap revetment along the north wall of West Island

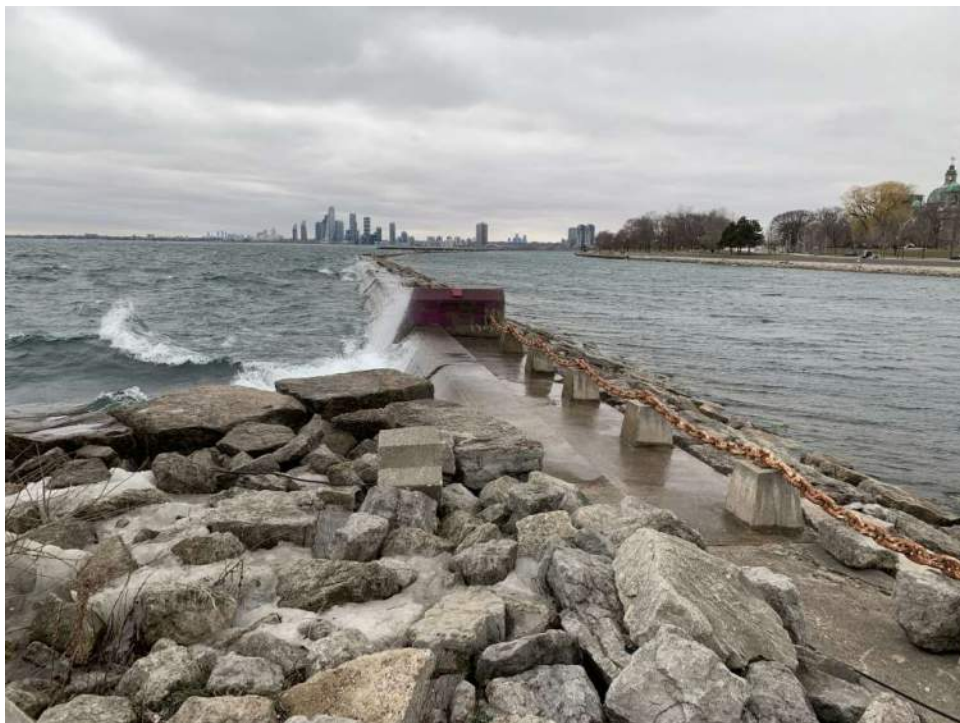
Figure 2.11: View to the west of exposed existing breakwater extending westward from the West Island

Past the westerly end of the West Island, the lakeside of the existing breakwater is exposed to wave action (see Figure 2.11), and the inner side is protected from overtopping waves with armour stone (Figure 2.12) that was installed at the same time as the rip rap revetment, described above.

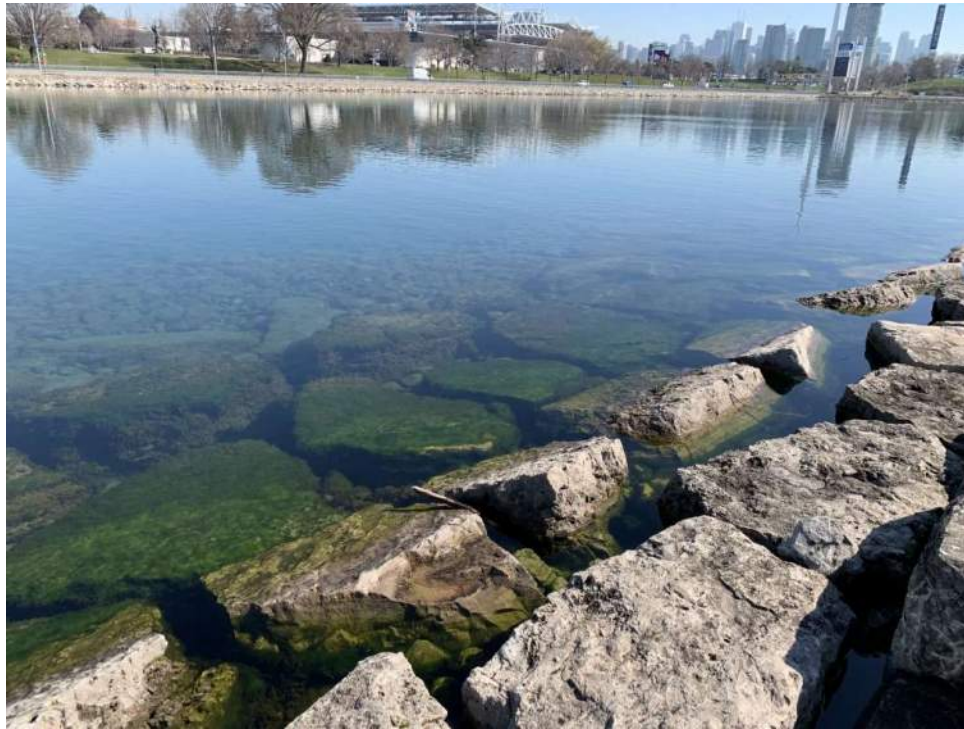
Figure 2.12: Armour stone along the inner side (north side) of the westerly portion of the existing breakwater

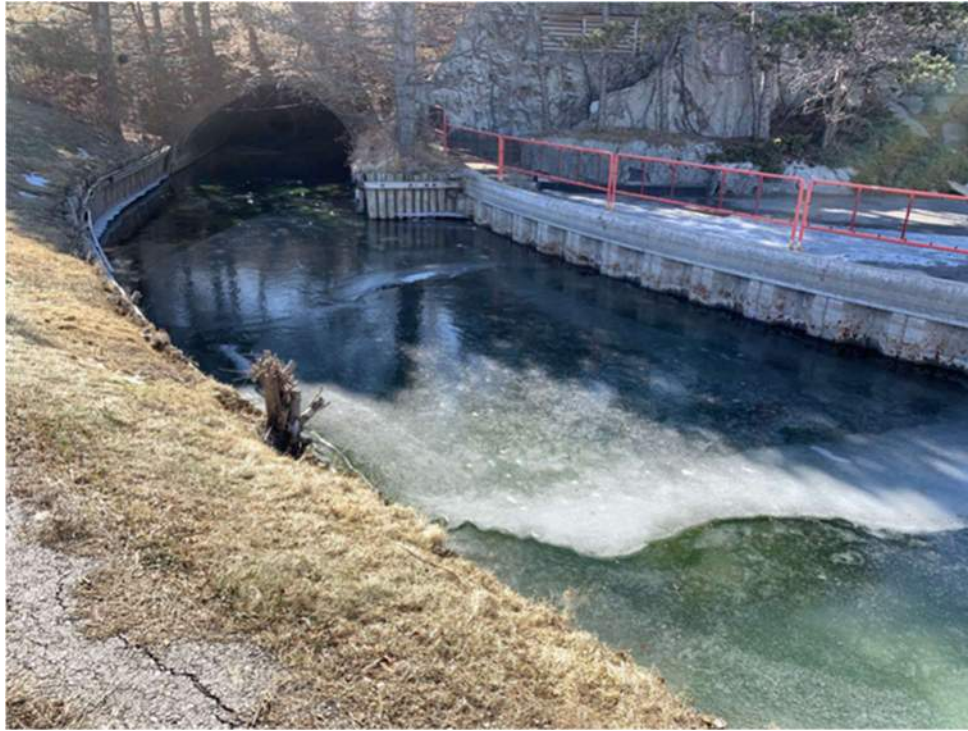
Figure 2.13: Steel sheet pile wall and timber pile wall at the east shore of West Island

The east shore of the West Island is protected with various structures, including steel sheet piling (see Figure 2.13), timber piling, stacked armour stone walls and rip rap revetments. Jacobs (2020) assessed the steel sheet piling, armour stone units wall and riprap conditions as “satisfactory to fair”; Shoreplan (2022) assessed the SSP conditions as “fair” and the armour stone as mostly “good” with some sections in a bit of disarray. Both Jacobs (2020) and Shoreplan (2022) noted that the area protected by timber piling showed signs of decay and some damage to the anchorages; the overall condition of the timber piling flood defence was assessed by Jacobs and Shoreplan as “poor”. The shoreline elevation is lower than the 100-year flood level and is subject to flooding at high water levels. There are no intentional aquatic habitat features incorporated into the shoreline.

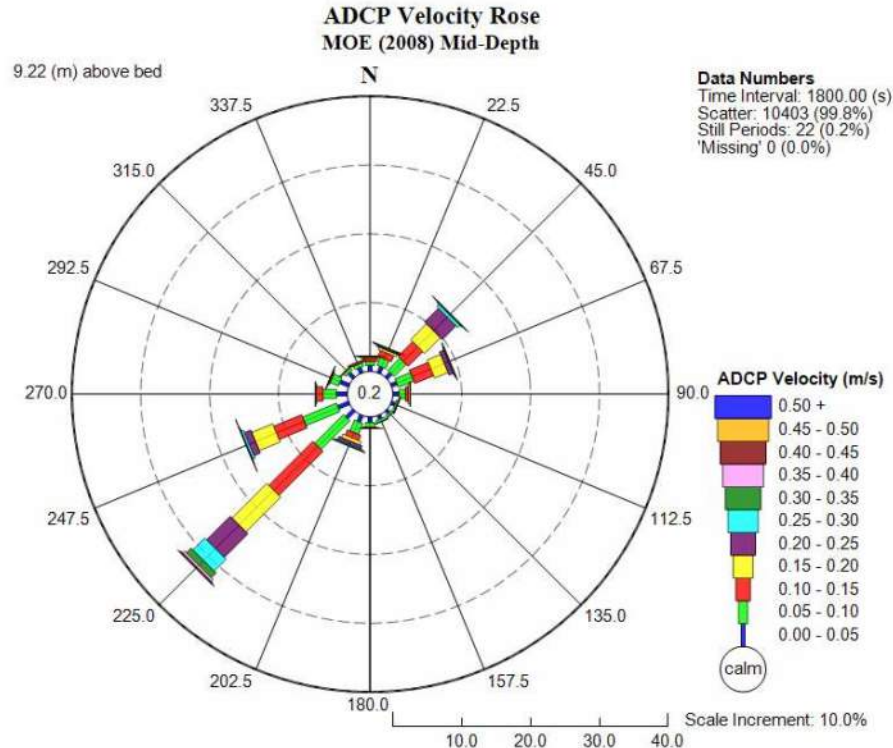
Figure 3.6: Current rose at mid-depth, east of Toronto Harbour

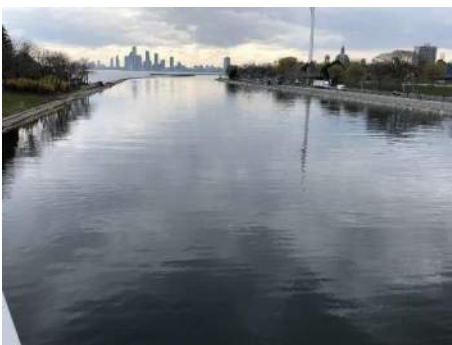
Figure 3.15: North Shore Looking West

The North and East shores (see Figure 3.15 and Figure 3.16) of the island are generally more sheltered and protected from the wave action of Lake Ontario, when compared to the South and West Shores. The North and East shores provide cover, nutrient input, foraging opportunities and may support limited spawning for warmwater species that build nests such as Pumpkinseed (*Lepomis gibbosus*) and Northern Pike (*Esox lucius*), which deposit eggs that stick to submerged aquatic vegetation. The presence of fine sediments along larger cobbles on the shore, provide habit types for some species in the calmer back-

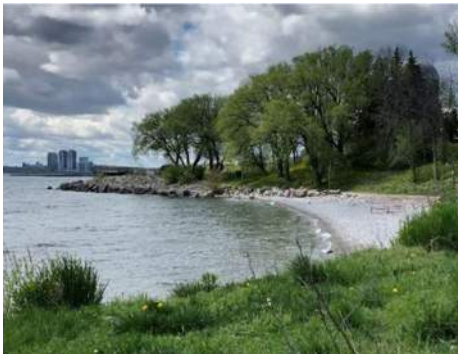
Figure 3.17: South Shore Looking West

A south facing gravel beach occurs on the west island (Figure 3.17). This feature is subject to wave action from the open waters of Lake Ontario. Wave action and general lack of shelter limits opportunities for aquatic vegetation to establish and grow, thus limiting feeding and refuge areas for fish along this part of the shoreline.

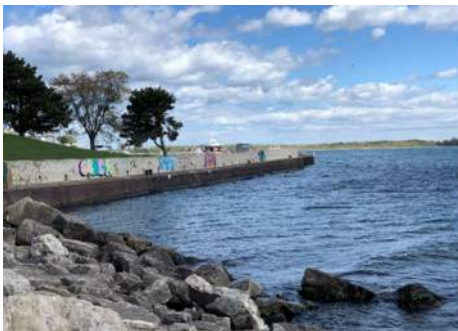
Figure 3.18: South Shore Looking South

On land developments and shoreline protection efforts have produced vertical walls of either concrete, steel pilings, or wood pilings that form the shoreline along many sections of

Ontario Place (Figure 3.18). Vertical shorelines eliminate depth gradients and reduce establishment of submergent and emergent vegetation that could provide cover and habitat for fish and food sources. Thus, these structures provide minimal opportunities for aquatic species to utilize these features for refuge spaces, foraging habitat, or spawning locations. The water depth is approximately 6-8 m at the shoreline and increases with distance from the shore.

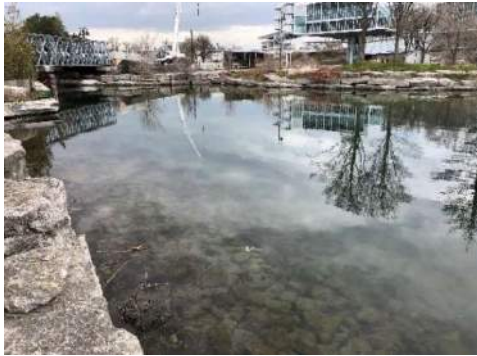
Figure 3.19: Back Channel West Island Looking North

Land based developments and shoreline protection efforts have produced vertical walls of either concrete, steel pilings, or wood pilings that form the shoreline along many sections of Ontario Place (Figure 3.19). These features provide minimal opportunities for aquatic species to utilize them for refuge spaces, foraging habitat, or spawning locations. This shoreline habitat is adjacent to back-channel habitat within Ontario Place, which is defined by shallow slow-moving water generally confined to narrower banks and more protected from wind and wave action. Soft substrates such as muck, silt, sand, and detritus.

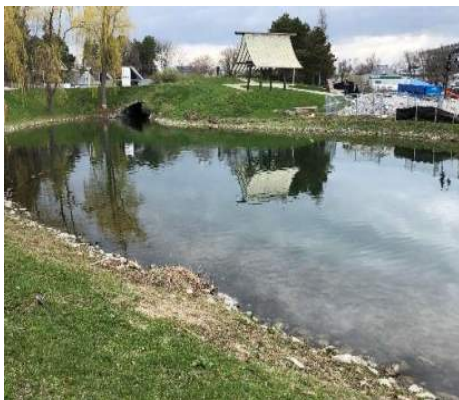
Figure 3.20: Back Channel West Island Looking North

Combinations of boulders, riprap, and armour stone make up the dominant class of substrate for these areas (Figure 3.20). The large substrate comprising the banks provide moderate habitat for fish through refuge spaces, nutrient collection, or potential spawning locations, relative to other features. This shoreline habitat is adjacent to back-channel habitat within Ontario Place, which is defined by shallow slow-moving water and soft substrates such as muck, silt, sand, and detritus.

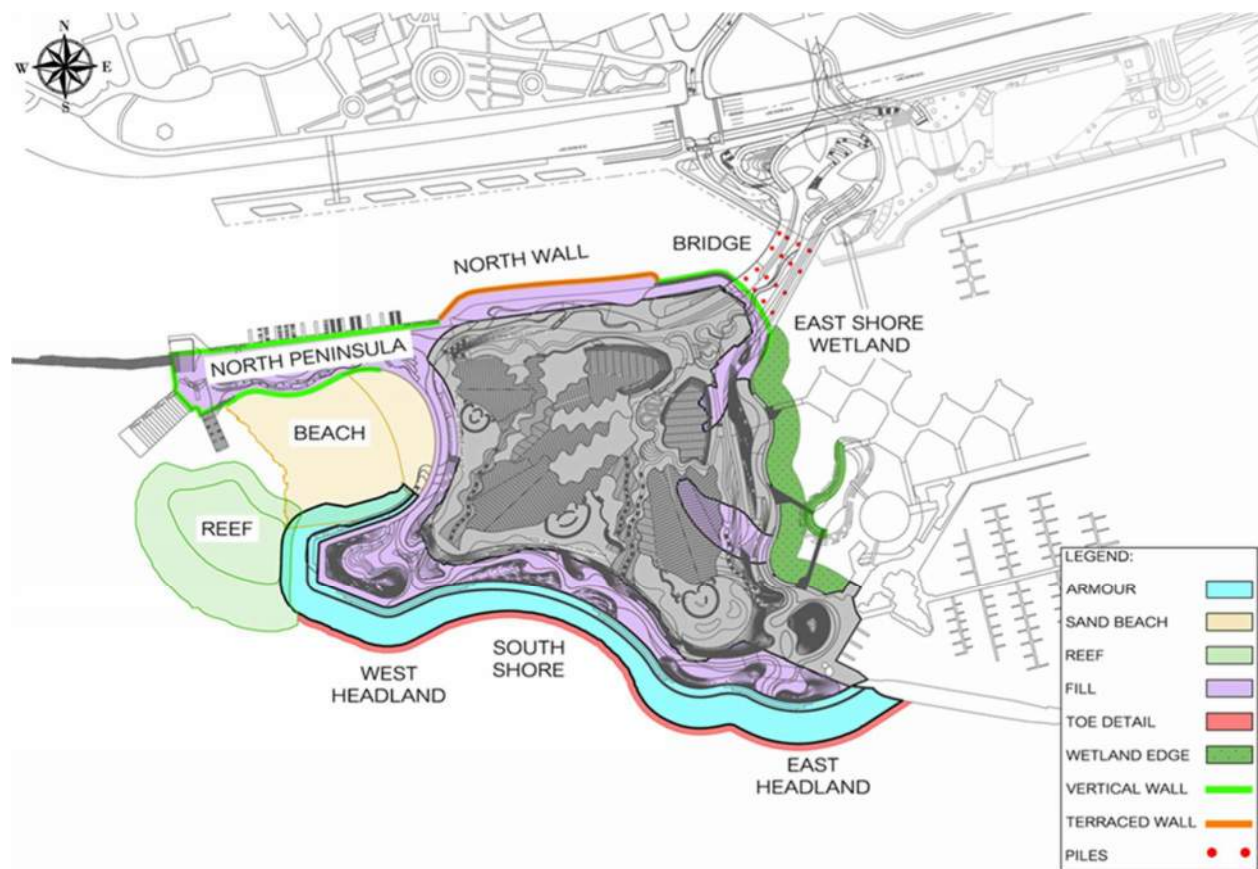
Figure 4.1: Primary elements of proposed shoreline enhancements, West Island Ontario Place

- West shore beach (Section A; Station -0+075)
- West headland and submerged reef (Section B; Station 0+095)
- West headland (Section C; Station 0+200)
- South shore revetment (Section D; Station 0+325)
- East headland (Section E; Station 0+500)

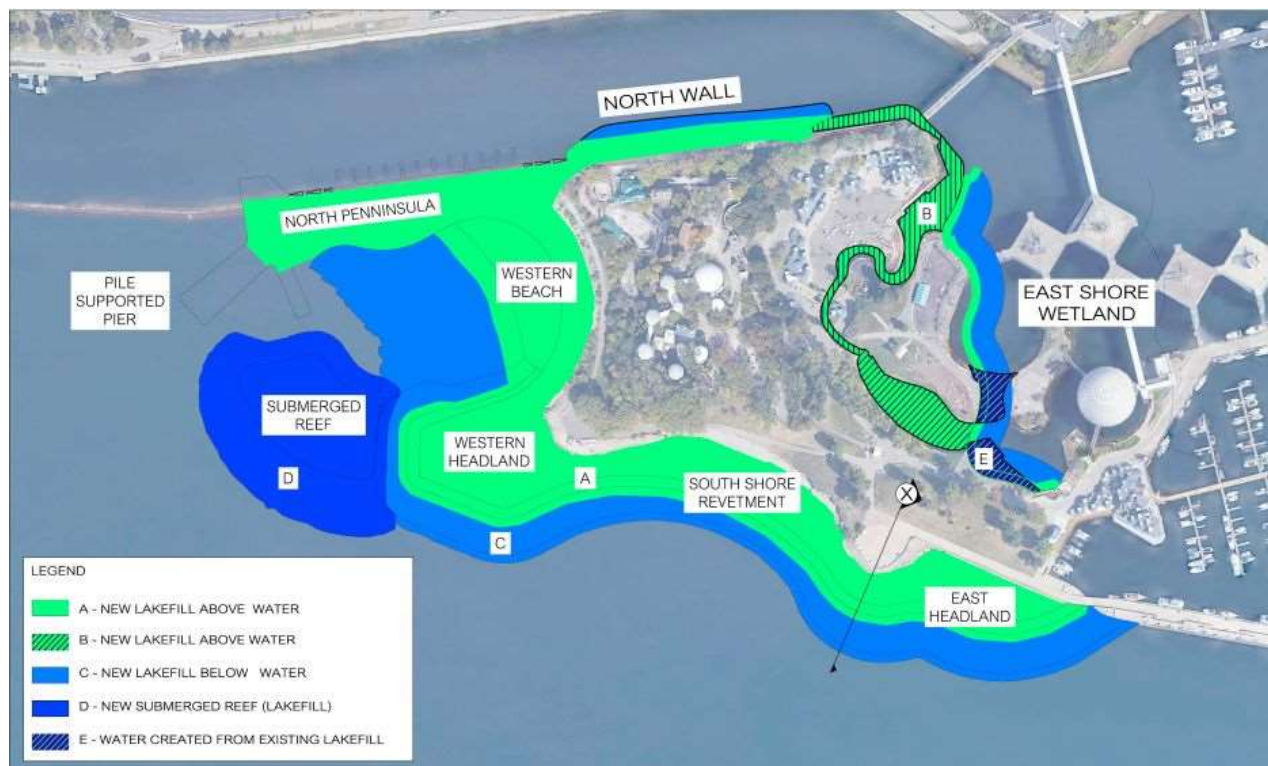
Figure 4.3: West Island lakefill areas (see Figure 4.4 for further definition of areas)

A preliminary estimate of the shoreline lakefill volume, including stone protection material, stone core, beach material, reef material, and clean fill is approximately 320,000 m³; a breakdown of the lakefill volume is provided in Table 4.2. The swim pier is pile-supported above the water and does not require significant filling in the lake. The fill material will be clean and meet the requirements of the Ontario Fill Quality Guide for Shore Filling.

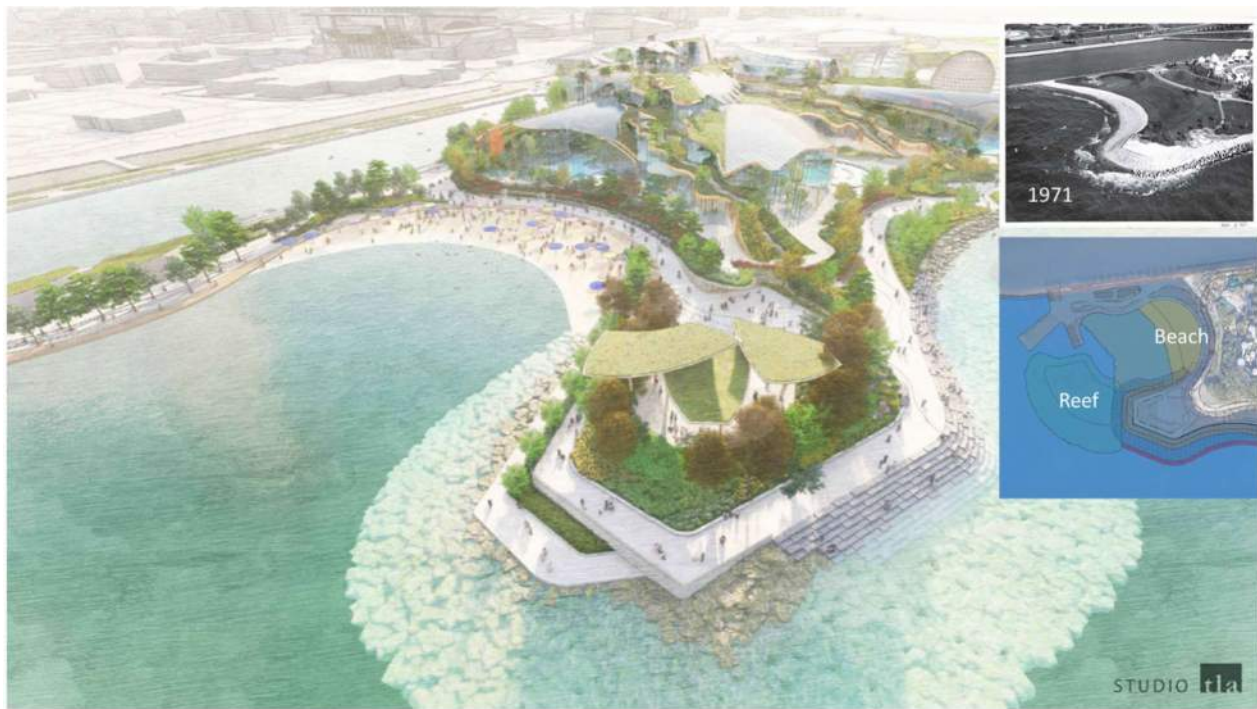
Figure 4.7: Concept for west beach and west headland. The lower inset image indicates the concept reef structure (shown in green) extending off the end of the proposed west headland. The upper inset shows the west headland and west shore as it was originally constructed in 1971.

A public sand beach is proposed at the west shore to replace the existing stacked armour stone seawall. Creation of the new sand beach will provide a safe wading and swimming experience. The beach will be integrated with a nearshore reef; the reef will reduce wave action at the shore and provide valuable aquatic habitat. The beach will significantly reduce wave uprush and flooding at the backshore that presently occurs. The concept for the beach and reef is shown in Figure 4.7. The beach location at the west shore is favourable because the beach can be contained between the existing north breakwater and the expanded west headland, reducing the potential for longshore loss of new beach material, and the nearshore depth of water is shallower than off the south shore which makes the volume of material required more manageable.
